ASSESSMENT OF THE TAKLA LANDING CONTOUR TRENCH WASTEWATER DISPOSAL SYSTEM

Assessment of the Takla Landing Contour Trench Wastewater Disposal System

May, 1989

NovaTec Consultants Inc.
Environmental Engineers & Scientists

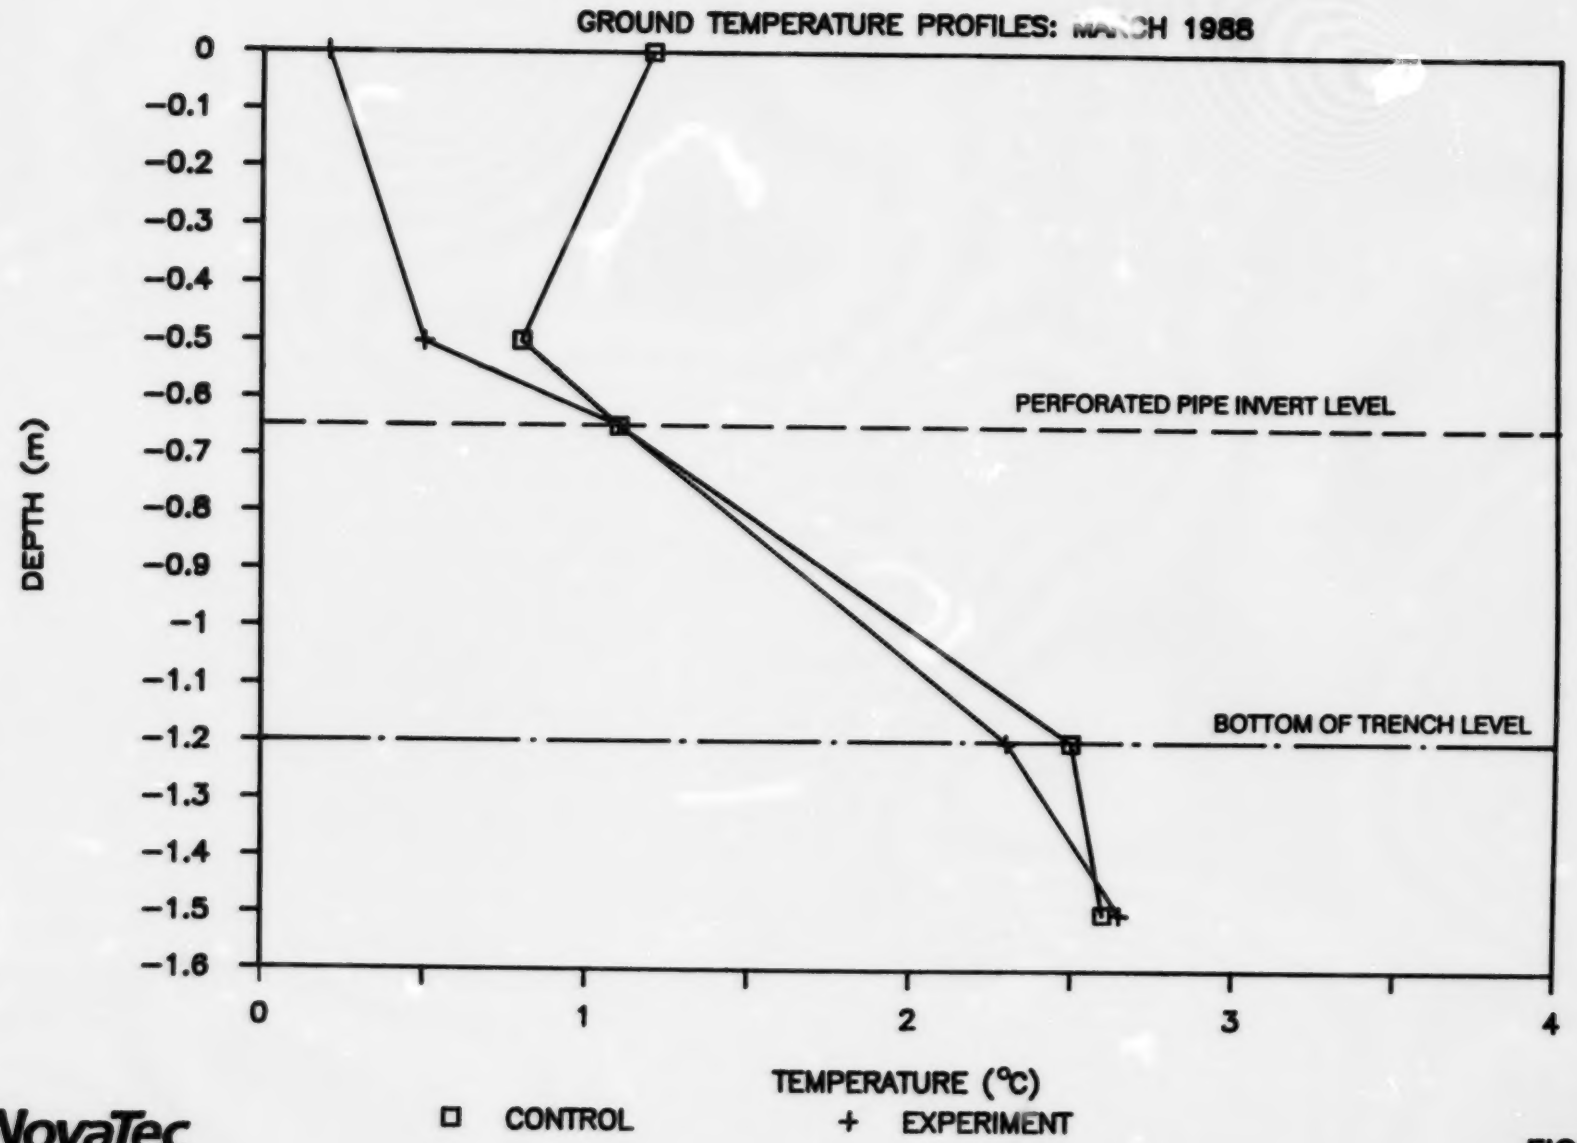
FIGURE 7

Ground temperature readings were measured twice during the March, 1988 site visit and control and experimental profiles based on the average reading are presented in Figure 7. Ground temperature profiles were also determined during the March 1989 site visit

and these are presented in Figure 8. The profiles are not substantially different at the greater depths, with some variation occurring at the ground level and 0.5 m depth. The ground level temperature variation is not considered to be of any significance as the thermistor arrays were placed inside protective boxes and the recorded temperature was largely a function of instantaneous site conditions at the time of measurement.

The winter conditions in 1988/89 were more severe than in 1987/88. As a result of prolonged temperatures below -20°C, the site visit was postponed until late March. The 0°C ground temperature at 0.5 m depth at both locations was probably a result of the prolonged intense cold.

Based on the late winter ground temperature profiles presented in Figures 7 and 8, the trench bottom and perforated disposal pipe depths of 1.2 m and 0.65 m, respectively, are satisfactory depths to prevent severe freezing under prolonged periods of extremely cold temperatures.

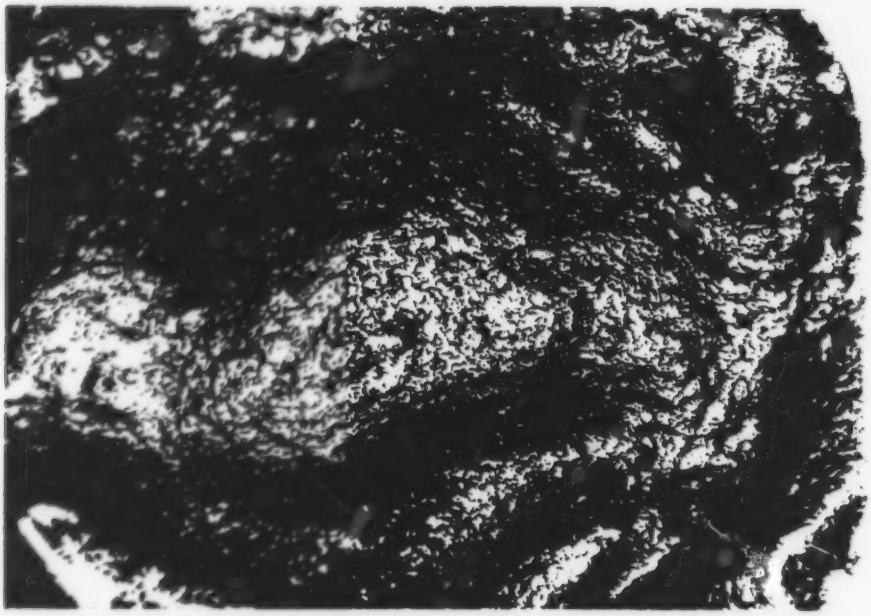
Photo 1: Well-developed biomat on geotextile fabric in Biomat Sampler No. 1 - March 1988.

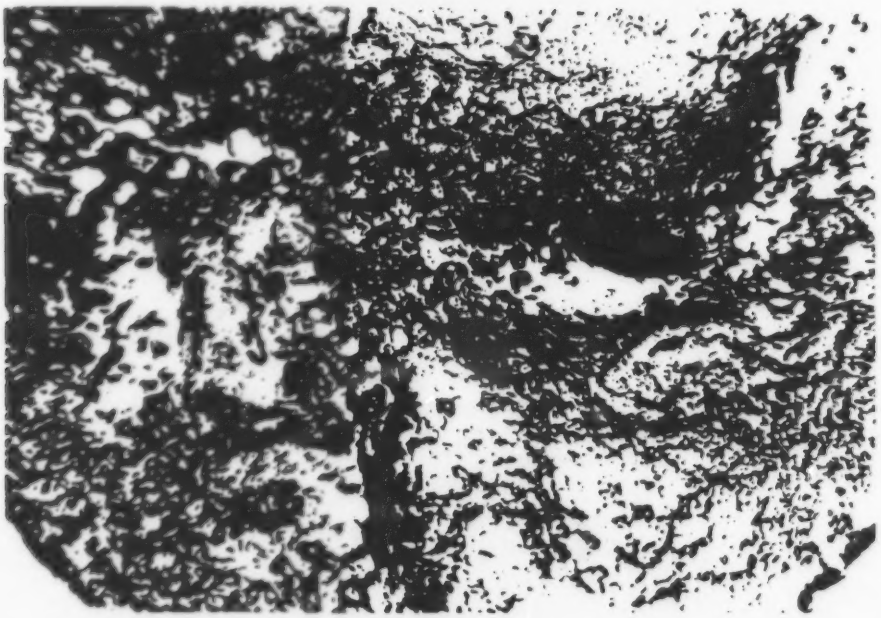
Photo 2: Well-developed biomat on geotextile fabric in Biomat Sampler No. 3 - March 1988.

Photo 3: Underside of geotextile fabric in Biomat Sampler No. 3 - March 1988.
